Manhole Inspection Summary

Manhole # S19KK_047MH

Insp Date: **6/5/07 8:46 AM**

Location Address: **2003 PULASKI-PAYSON**

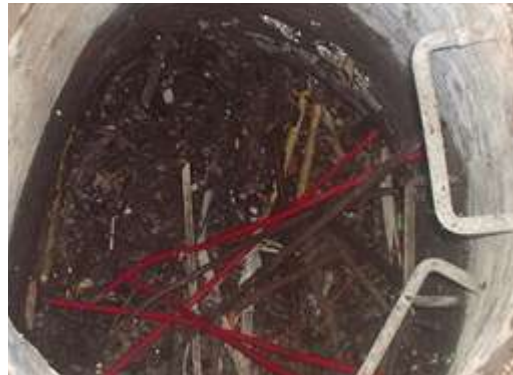
Top View

Condition: ☐ Sound ☐ Cracked ☐ Root Intrusion ☐ Deteriorated ☐ Leaks ☒ **Debris**

DEBRIS IN CHANNEL

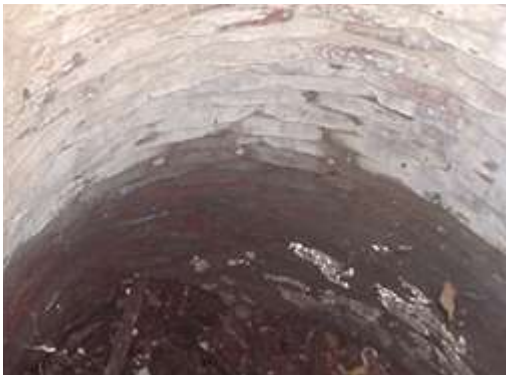
Defect 2

Infiltration: ☐ None ☒ **Joint** ☐ Cracks ☐ Mortar ☐ Roots ☐ Wall

BARREL INFILTRATION

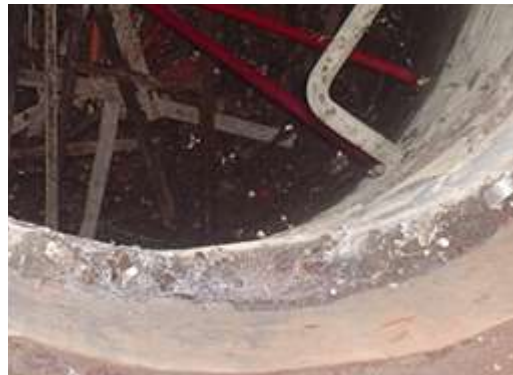
Defect 1

Frame Offset: **1** (in.) Condition: ☒ Sound ☐ Cracked ☐ Leaks

FRAME OFFSET

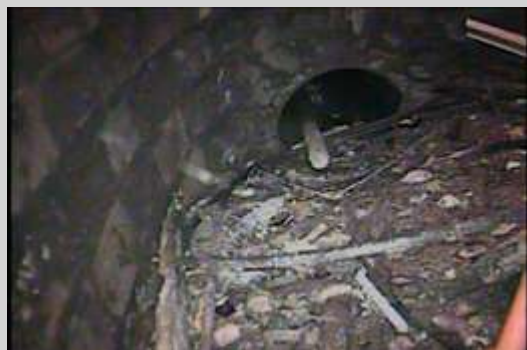
12 O'Clock Outflow

8 in. Circular Gravity Sewer
Pipe Out @ 12 O'Clock

Deposits: ☐ None ☐ Mud ☐ Sludge ☒ **Debris** ☐ Grease

Silt Depth: **4** (in.) Deposits Extent: **Medium**
